Contract #: 04-0120F4Cty: SF/ALA Rte: 80 PM: 13.9/14.3,0.0/1.6File #: 69.28**WELDING INSPECTION REPORT****Resident Engineer:** Pursell, Gary**Address:** 333 Burma Road**City:** Oakland, CA 94607**Report No:** WIR-000836**Date Inspected:** 09-Nov-2007**Project Name:** SAS Superstructure**OSM Arrival Time:** 1430**Prime Contractor:** American Bridge/Fluor Enterprises, a JV**OSM Departure Time:** 2300**Contractor:** Zhenhua Port Machinery Company, Ltd (ZPMC), Changxing Island **Location:** Shanghai, China**CWI Name:** Sha Xi & Wang Gaifa**CWI Present:** Yes No**Inspected CWI report:** Yes No N/A**Rod Oven in Use:** Yes No N/A**Electrode to specification:** Yes No N/A**Weld Procedures Followed:** Yes No N/A**Qualified Welders:** Yes No N/A**Verified Joint Fit-up:** Yes No N/A**Approved Drawings:** Yes No N/A**Approved WPS:** Yes No N/A**Delayed / Cancelled:** Yes No N/A**Bridge No:** 34-0006**Component:** OBG - Closed Rib Trials & Mock Up**Summary of Items Observed:**

Orthotropic Box Girder (OBG):

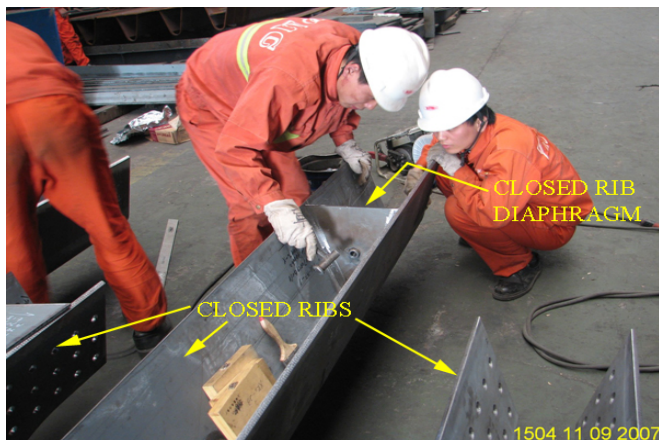
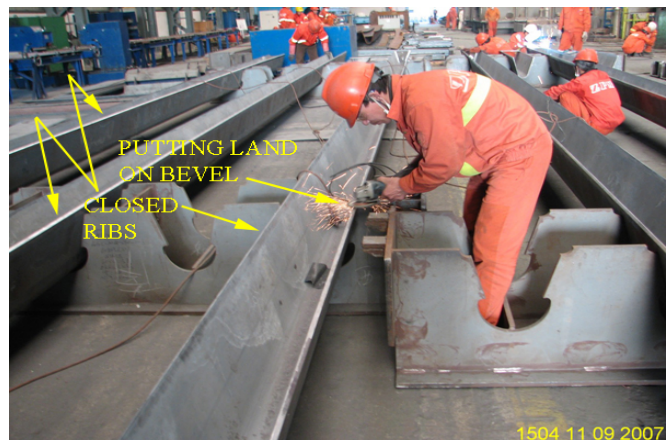
The QA Inspector randomly observed ZPMC tack welder Gang Zhiwu ID Number 070503030, utilizing the Flux Cored Arc Welding (FCAW) Process with ZPMC approved Weld Procedure Specification (WPS)

WPS-B-T-2342-U2, to tack weld diaphragms as they were being fit up into closed ribs. The QA Inspector also observed several ZPMC helpers utilizing grinders to place the lands on other closed ribs. The following photographs provide additional detail.

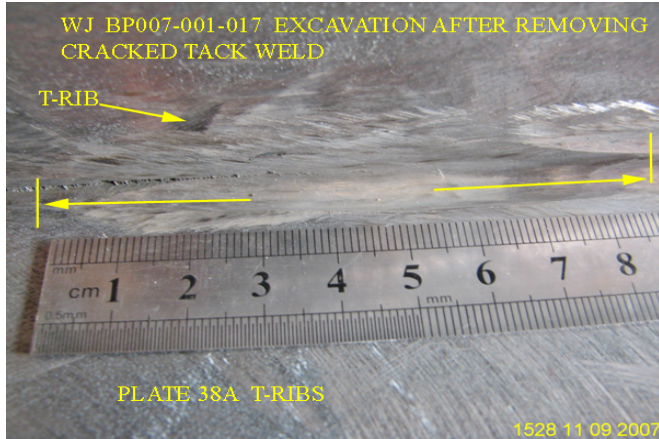
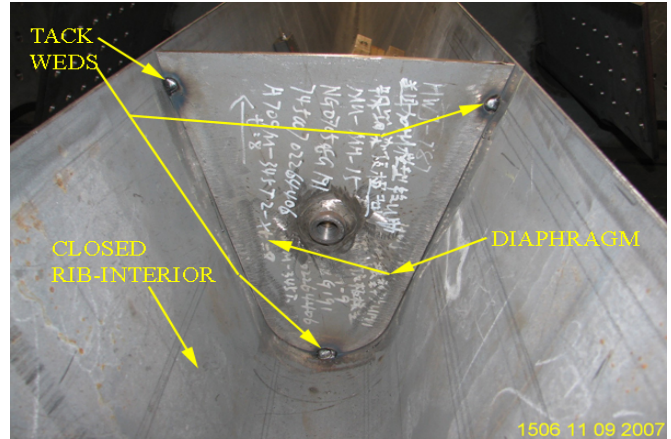
The QA Inspector randomly observed ZPMC helpers utilizing grinders to remove cracked tack welds on T-ribs fit up on T-Rib Assembly Plate 38A in Bay 3. The QA Inspector also randomly observed that during the removal of the cracked tack welds, some of the base metal on T-Rib Assembly Plate 38A, had been removed. The QA Inspector randomly observed ZPMC Non Destructive Technician (NDT) Cai Xin Xin, utilizing the Magnetic Particle Testing (MT) method to examine the excavations in T-Rib Assembly Plate 38A, prior to performing base metal repair. The QA Inspector observed that there were a total of 10 cracked tack welds that had been removed,

and all 10 areas had excavations in the base metal of the T-Rib Assembly Plate 38A. The excavated areas were on Weld Joint (WJ) Number BP007-001-013 (3each), WJ BP007-001-017 (4 each), WJ BP007-001-22 (2 each) and WJ BP007-001-23 (1 each). The following photograph provides additional detail.

Art Peterson of American Bridge/Fluor Enterprises, a JV, (ABF), informed the QA Inspector that both ZPMC and ABF had observed cracks in several tack welds attaching T-Ribs to Plate 38A. Mr. Peterson also informed the QA Inspector that the ZPMC personnel had "gotten a little carried away with the grinders trying to remove the cracked tack welds, and had removed some of the base metal on Plate 38A". Mr. Peterson further informed the QA Inspector, that the excavations resulting from the cracked tack weld removal would be examined with the Magnetic Particle Testing Method by ZPMC and then repaired.
